### Inspection Report

### Minerals Regulatory Program

<b>Mine Name:</b> Point of Mountain (South Hansen)	<b>Permit Number:</b> M/035/0026
<b>Operator Name:</b> Geneva Rock Products	<b>Inspection Date:</b> September 30, 2009
<b>Inspector(s):</b> L Heppler	<b>Time:</b> 7:00 AM
<b>Other Participants:</b> Operator Representative	<b>Mine Status:</b> Active

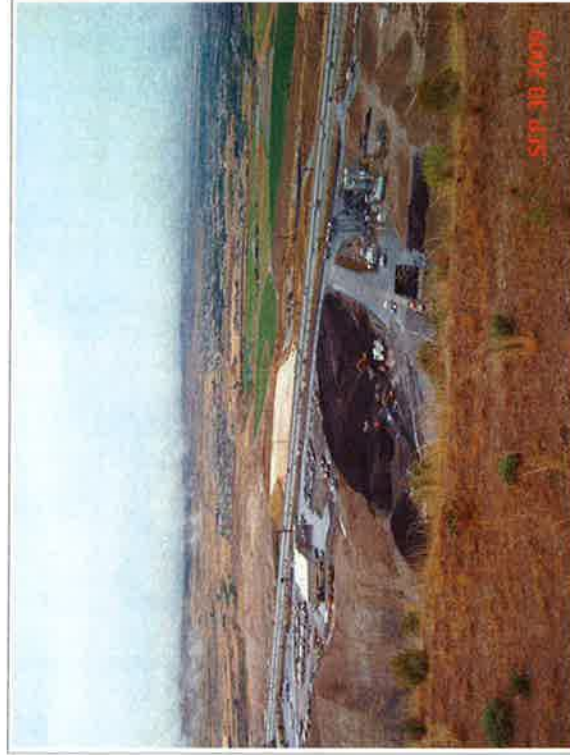
Overview of mine site – looking west

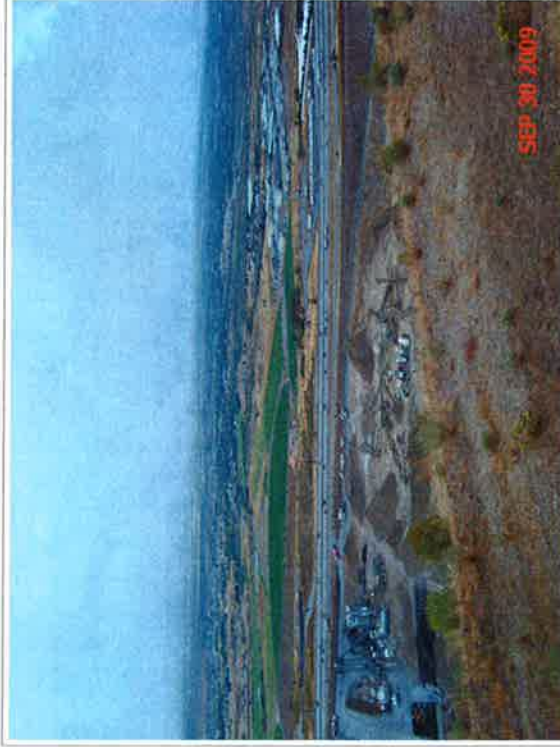
Overview of mine site – looking west

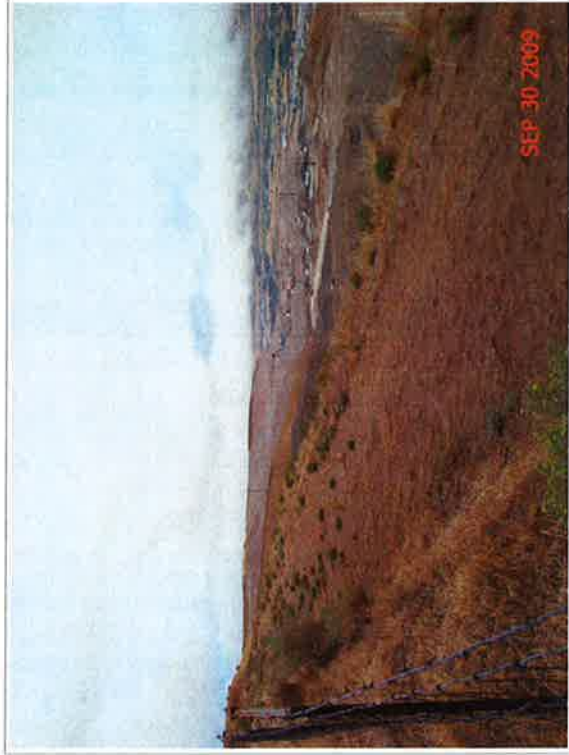
Overview of mine site – looking southwest

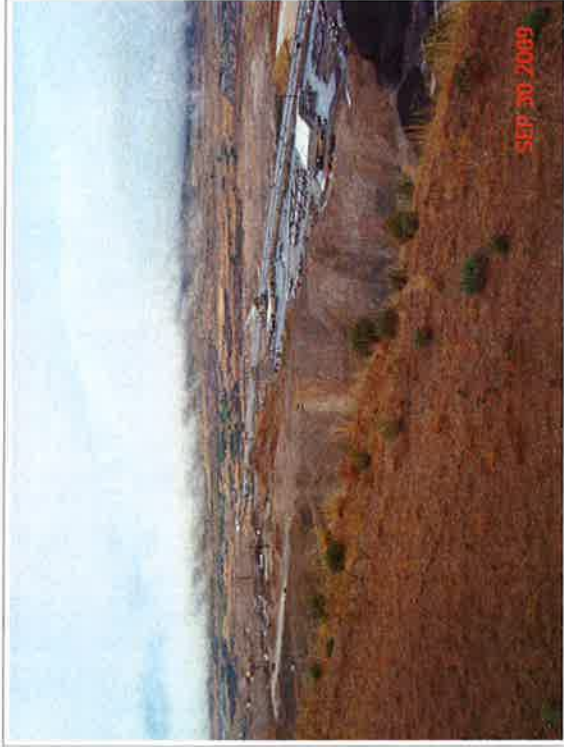
Overview of mine site – looking southwest

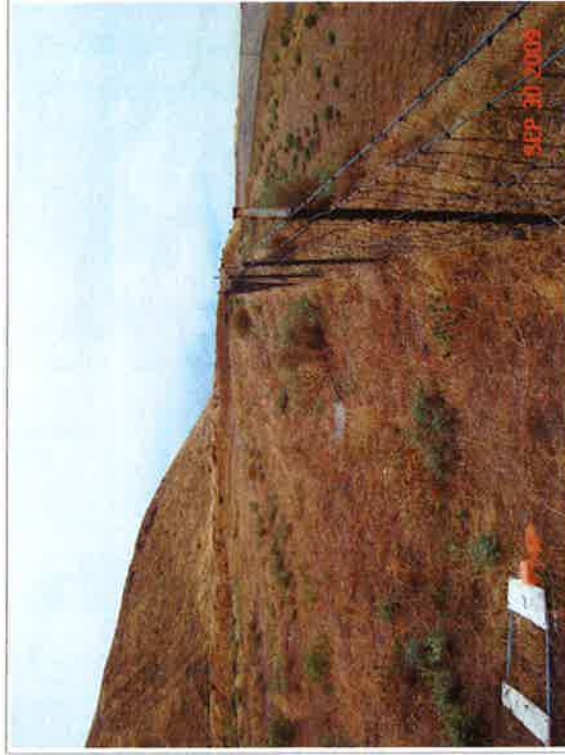
Fence on east perimeter

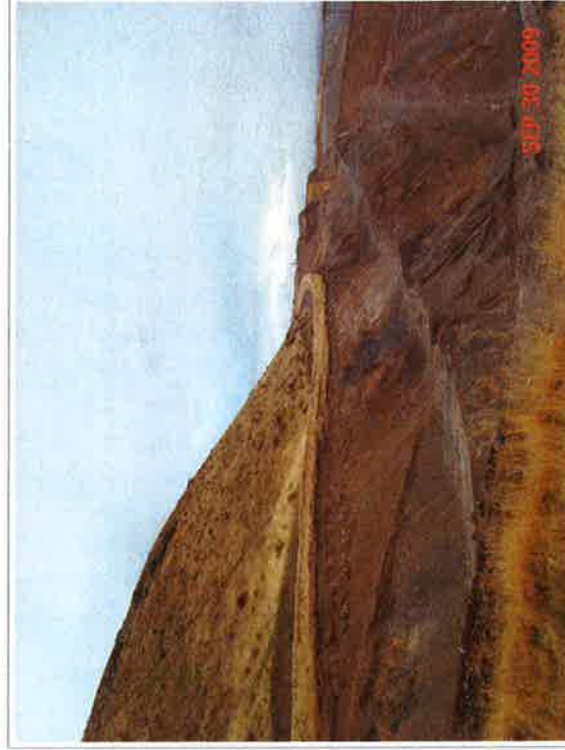
Upper slope of rock pit

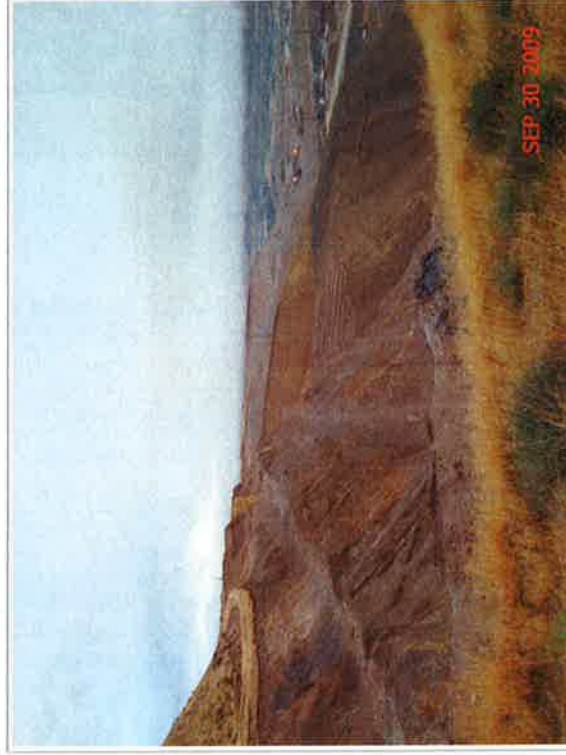
Upper slope of rock pit

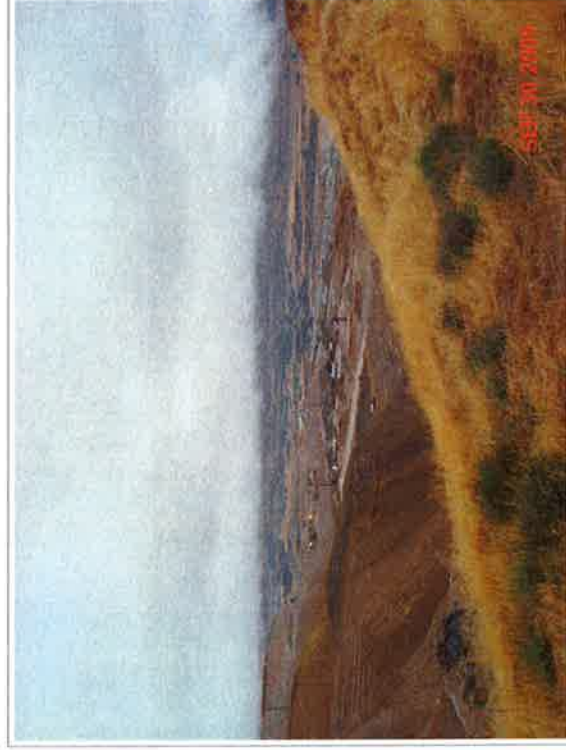
Lower slope of rock pit
